Manhole Inspection Summary

Manhole # S08II2014MH

Insp Date: **7/10/06 7:33 AM**

Location Address: **7350 PSRK VILLAGE CT**

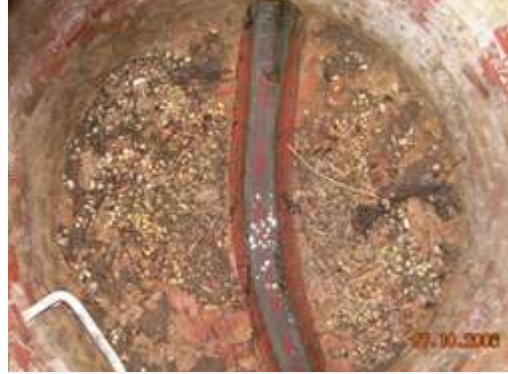
Top View

Bench debris.

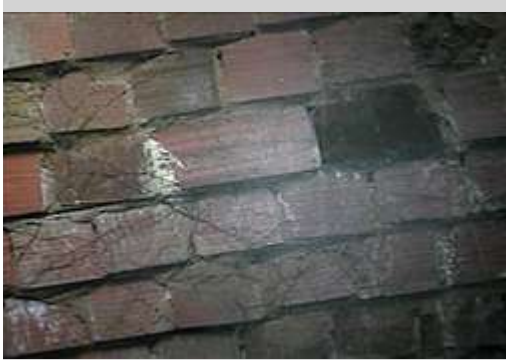
Defect

Condition: ☐ Sound ☐ Cracked ☒ **Root Intrusion** ☐ Loose Brick ☐ Deteriorated

Infiltration: ☐ None ☐ Joint ☐ Cracks ☒ **Mortar** ☒ **Roots** ☐ Wall

Corbel and Barrel root intrusion.

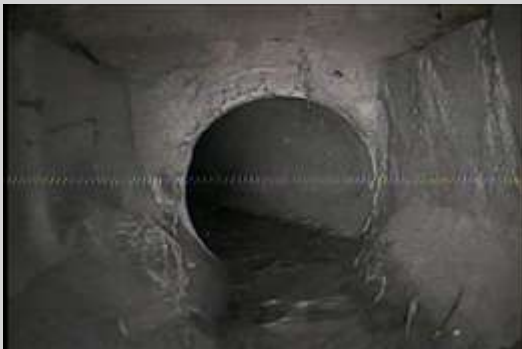
6 in. Circular Gravity Sewer Pipe In @ 5 O'Clock

Channel root intrusion.
